ASBESTOS DEMOLITION SURVEY REPORT

Arklow Main Drainage Site

Ferrybank

Irish Water.

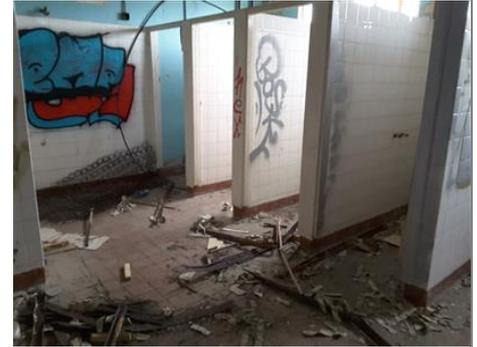
Building/Area : Wallboard Site
Room/Section : Main Building
Location : Toilets
Description : All Walls Floor and Ceilings
Sample No. :
Confirmation : --N/A--
Access : Full Access
Normal Use :
Recommendations :

; While no asbestos containing materials were identified during this survey it is possible that asbestos containing materials may be hidden and not accessible until demolition/ refurbishment commences. Asbestos containing materials must be removed prior to demolition or where refurbishment works may disturb them.

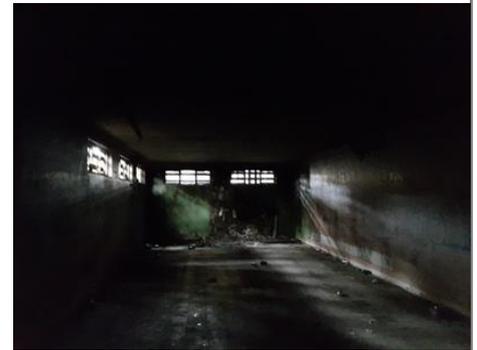
Location Details 204373 No Asbestos Found

Building/Area : Wallboard Site
Room/Section : Main Building
Location : Locker Room
Description : All Walls and Ceilings
Sample No. :
Confirmation : --N/A--
Access : Full Access
Normal Use :
Recommendations :

; While no asbestos containing materials were identified during this survey it is possible that asbestos containing materials may be hidden and not accessible until demolition/ refurbishment commences. Asbestos containing materials must be removed prior to demolition or where refurbishment works may disturb them.

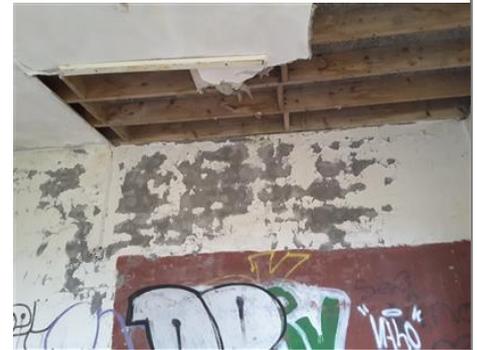
Location Details 204370 No Asbestos Found

Building/Area : Wallboard Site
Room/Section : Garage Building
Location : All Walls Floor and Ceilings
Description : Solid and Strawboard
Sample No. :
Confirmation : --N/A--
Access : Full Access
Normal Use :
Recommendations :

; While no asbestos containing materials were identified during this survey it is possible that asbestos containing materials may be hidden and not accessible until demolition/ refurbishment commences. Asbestos containing materials must be removed prior to demolition or where refurbishment works may disturb them.

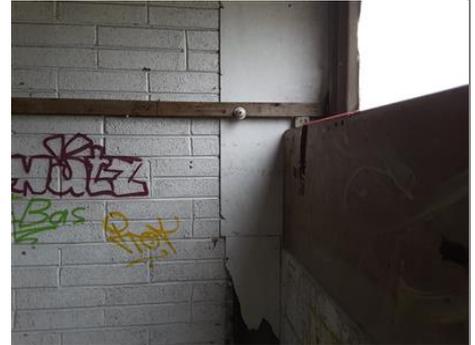
Building/Area : Wallboard Site
Room/Section : Stores Building
Location : Internal Boxing's
Description : Board
Sample No. : AMB20160323004
Confirmation : Sample Taken
Access : Full Access

Normal Use :
Recommendations :
; While no asbestos containing materials were identified during this survey it is possible that asbestos containing materials may be hidden and not accessible until demolition/ refurbishment commences. Asbestos containing materials must be removed prior to demolition or where refurbishment works may disturb them.

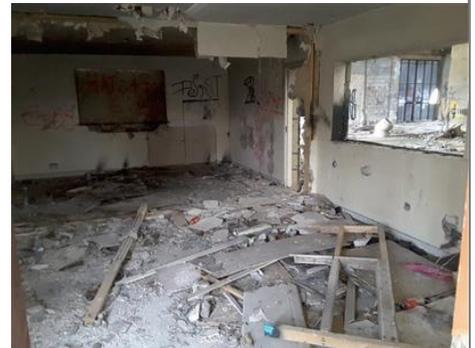
Location Details 204351 No Asbestos Found

Building/Area : Wallboard Site
Room/Section : Weatherglaze Building
Location : Offices
Description : All Walls Floor and Ceilings
Sample No. :
Confirmation : --N/A--
Access : Full Access

Normal Use :
Recommendations :
; While no asbestos containing materials were identified during this survey it is possible that asbestos containing materials may be hidden and not accessible until demolition/ refurbishment commences. Asbestos containing materials must be removed prior to demolition or where refurbishment works may disturb them.

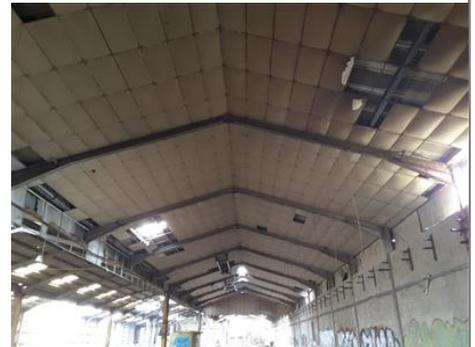
Location Details 204380 No Asbestos Found

Building/Area : Wallboard Site
Room/Section : Main Building
Location : Internal
Description : Plasterboard
Sample No. : AMB20160323008
Confirmation : Sample Taken
Access : Full Access

Normal Use :
Recommendations :
; While no asbestos containing materials were identified during this survey it is possible that asbestos containing materials may be hidden and not accessible until demolition/ refurbishment commences. Asbestos containing materials must be removed prior to demolition or where refurbishment works may disturb them.

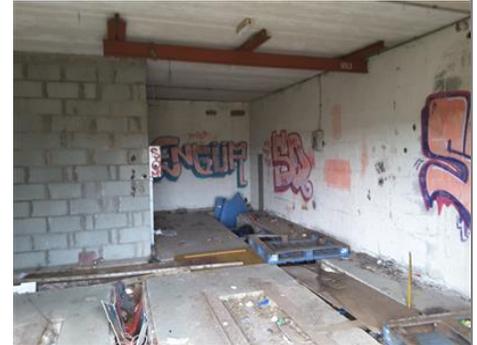
Building/Area : Wallboard Site
Room/Section : Main Building
Location : Transformer Room
Description : All Walls Floor and Ceilings
Sample No. :
Confirmation : --N/A--
Access : Full Access
Normal Use :
Recommendations :

; While no asbestos containing materials were identified during this survey it is possible that asbestos containing materials may be hidden and not accessible until demolition/ refurbishment commences. Asbestos containing materials must be removed prior to demolition or where refurbishment works may disturb them.

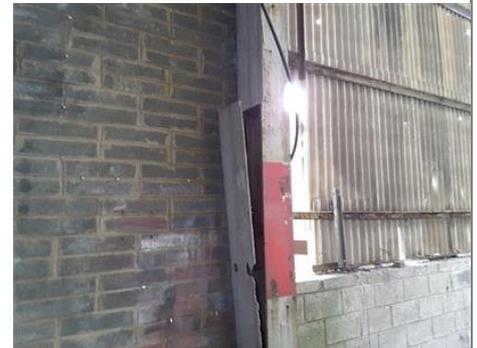
Location Details 204382 No Asbestos Found

Building/Area : Wallboard Site
Room/Section : Main Building
Location : Boxing
Description : Board
Sample No. : AMB20160323009
Confirmation : Sample Taken
Access : Full Access
Normal Use :
Recommendations :

; While no asbestos containing materials were identified during this survey it is possible that asbestos containing materials may be hidden and not accessible until demolition/ refurbishment commences. Asbestos containing materials must be removed prior to demolition or where refurbishment works may disturb them.

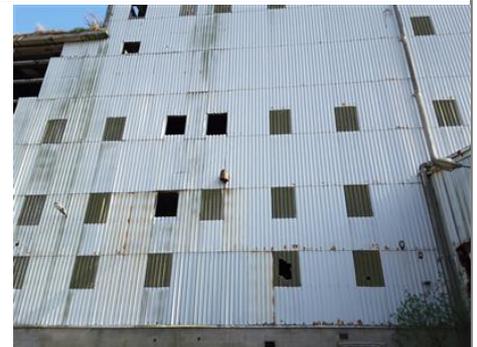
Location Details 204384 No Asbestos Found

Building/Area : Wallboard Site
Room/Section : Cladding
Location : Metal
Description :
Sample No. : AMB20160323010
Confirmation : Sample Taken
Access : Full Access
Normal Use :
Recommendations :

; While no asbestos containing materials were identified during this survey it is possible that asbestos containing materials may be hidden and not accessible until demolition/ refurbishment commences. Asbestos containing materials must be removed prior to demolition or where refurbishment works may disturb them.
