12 Archaeology, Architectural and Cultural Heritage

12.1 Introduction

This chapter describes the likely significant effects of the proposed development on archaeology, architectural and cultural heritage.

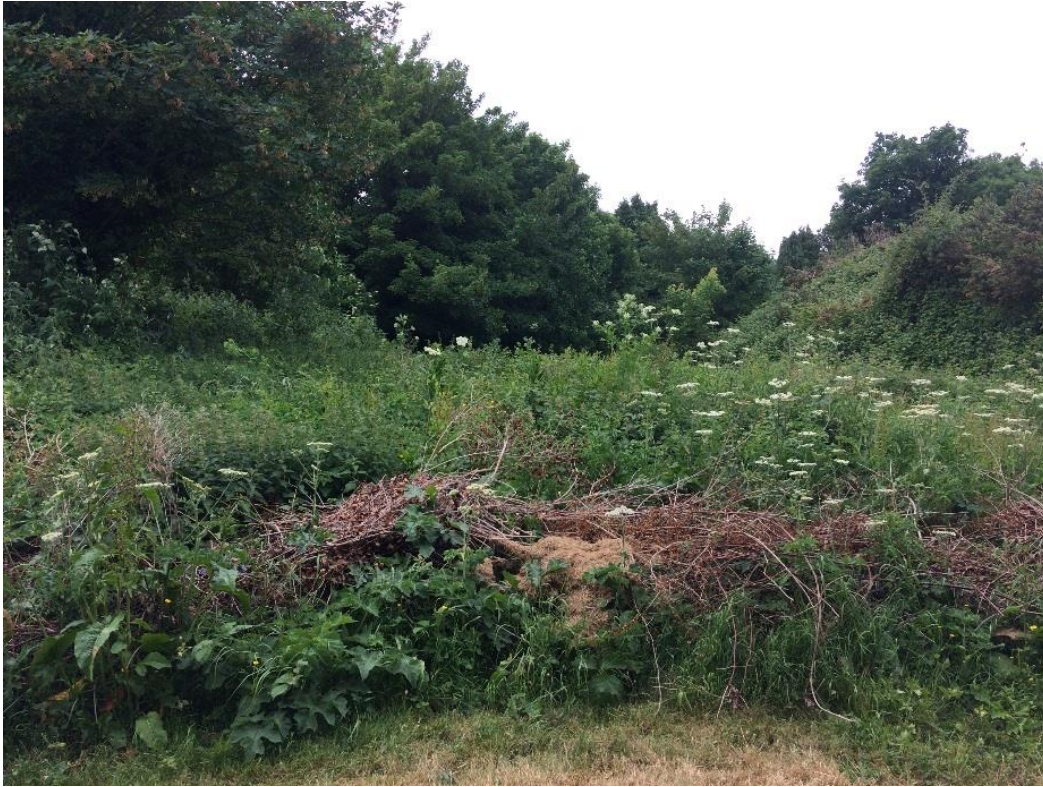
Although the area is very overgrown, the tower of the castle is just visible through the trees to the south.

Figure 12.6: The Alps site, facing southwest

The field inspection commenced at the western end of the proposed development at the site of the proposed Alps SWO and stormwater tank. The section of the site is located approximately 50m north of the ruins of Arklow Castle (WI029-029002) in an overgrown area that is bordered to the northwest and southeast by overgrown slopes (Refer to Figure 12.6). The historic mapping shows a stream running through this area, although it is no longer extant today.

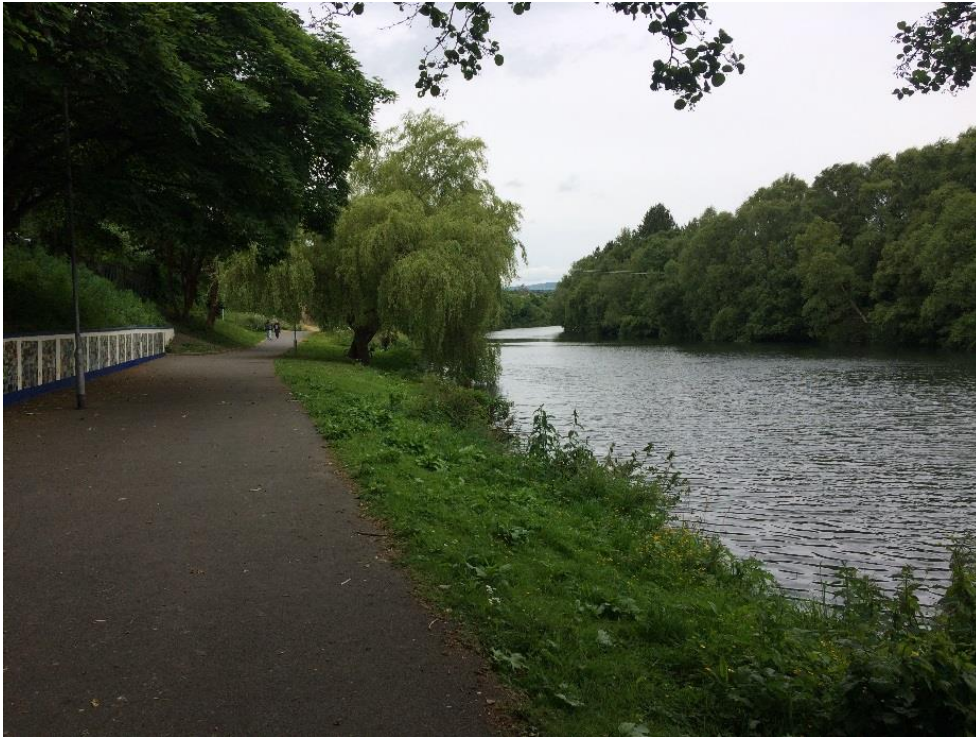
Figure 12.7: Route of proposed interceptor sewer adjacent to the Avoca River, facing west (upstream)

The proposed interceptor sewer runs in an easterly direction along the southern bank of the River Avoca. The first section is characterised by a modern footpath (Refer to Figure 12.7), which then joins River Lane and River Walk (Refer to Figure 12.8). This area represents made ground established to the north of the property boundaries to the south, which front onto Main Street. Although this section, the proposed development is located within the zone of archaeological potential for Arklow town and is in immediate proximity to the river, previous archaeological monitoring in this area failed to identify any features or deposits of archaeological potential.

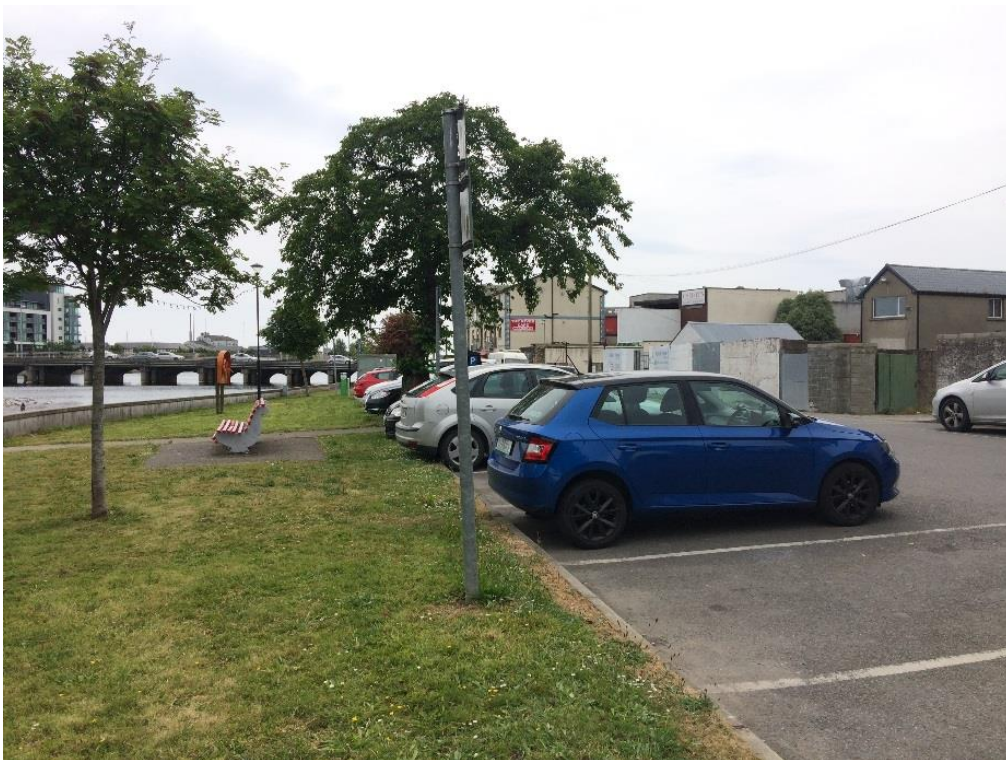
Figure 12.8: Route of proposed interceptor sewer along River Lane, facing southeast

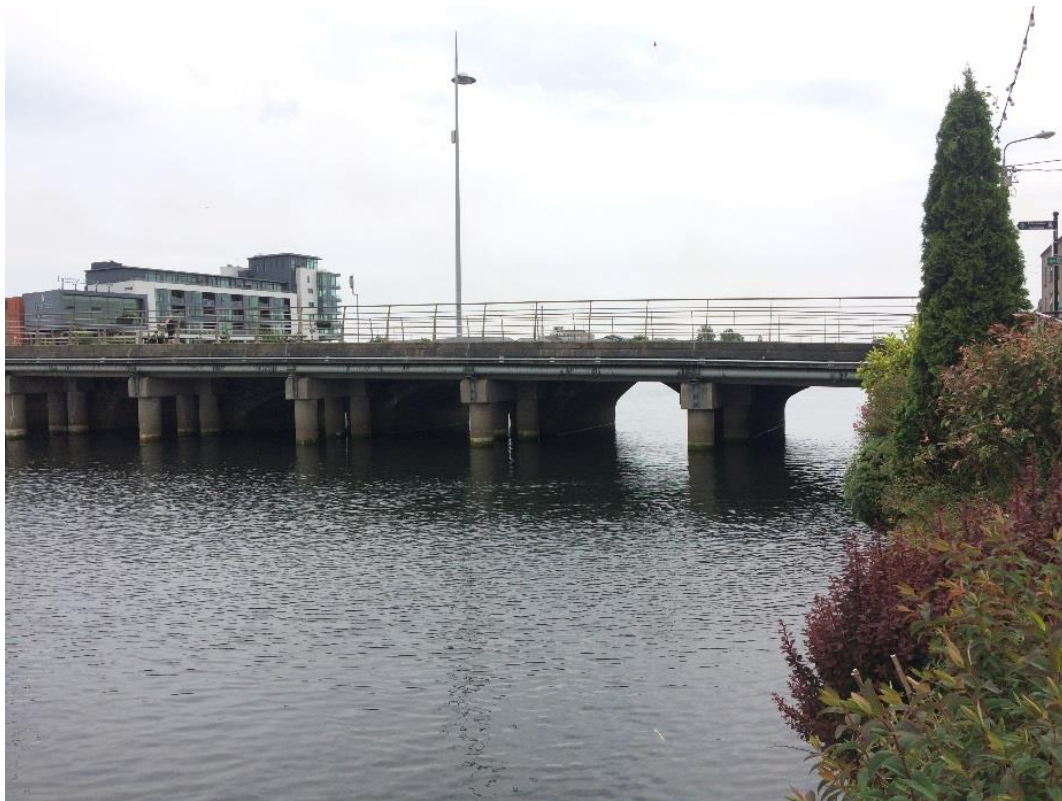
Figure 12.9: Arklow Bridge (RPS A26), facing east-southeast

As the proposed interceptor sewer reaches Arklow Bridge (RPS A26), it enters the existing river channel to pass underneath the southernmost arch. The arch is obscured from the west by the 1960s widening works (Figure 12.9). However, it is clearly visible from the east (Figure 12.10). A rubble wall, with a rendered cement coping abuts the eastern elevation of the bridge, to the immediate south of the arch (Figure 12.11).

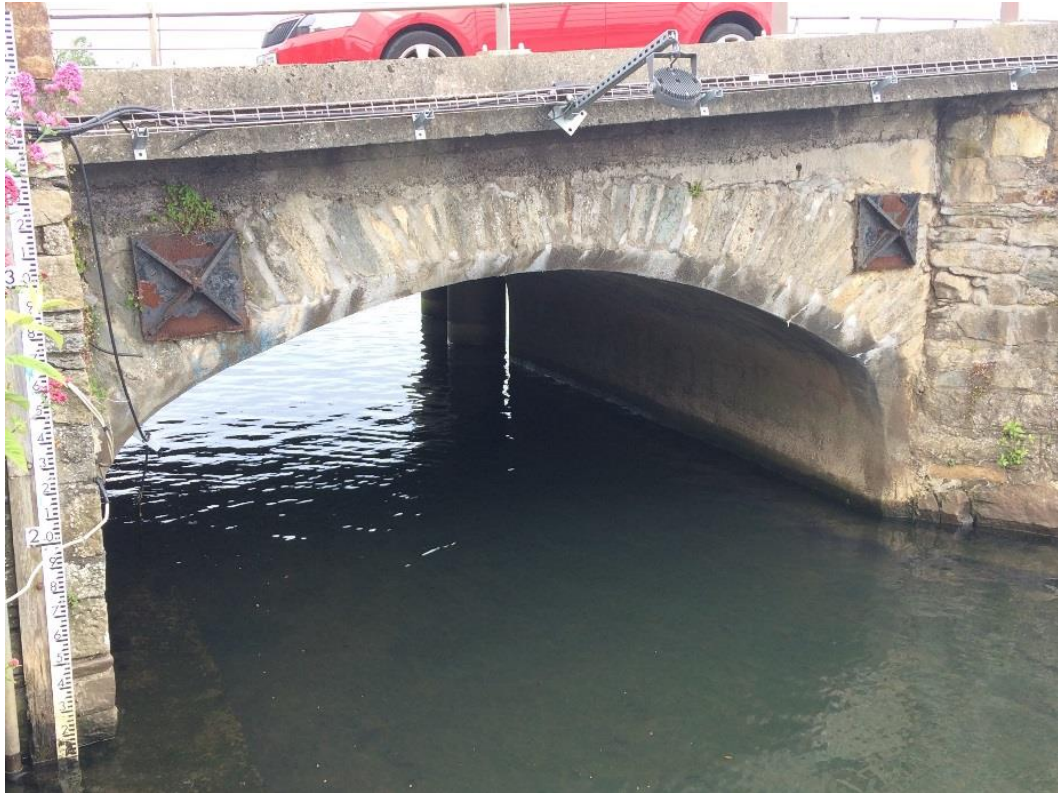
Figure 12.10: Southernmost arch of Arklow Bridge (RPS A26), facing northwest

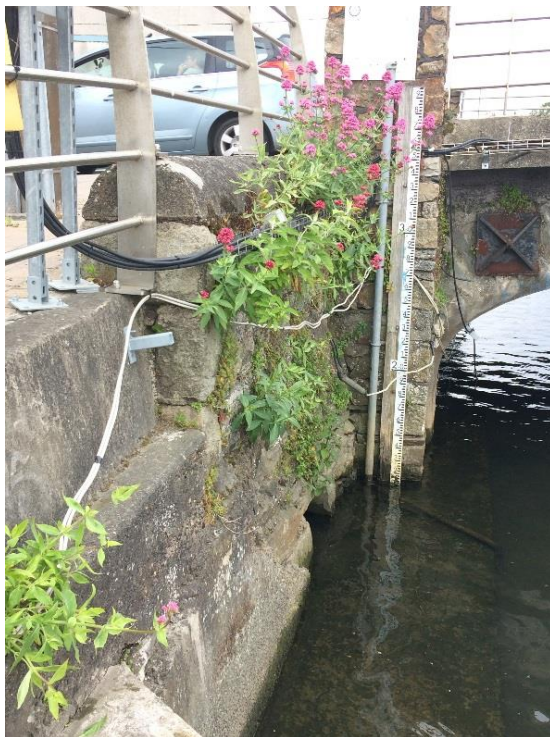
Figure 12.11: Wall abutting the south-eastern side of Arklow Bridge, facing northwest

It is possible that the wall represents the denuded remains of a wall associated with the southern quay, but a large amount of alterations have been carried out in this area. It is clear from the historic mapping that both the North and South Quays post-date the construction of the bridge.

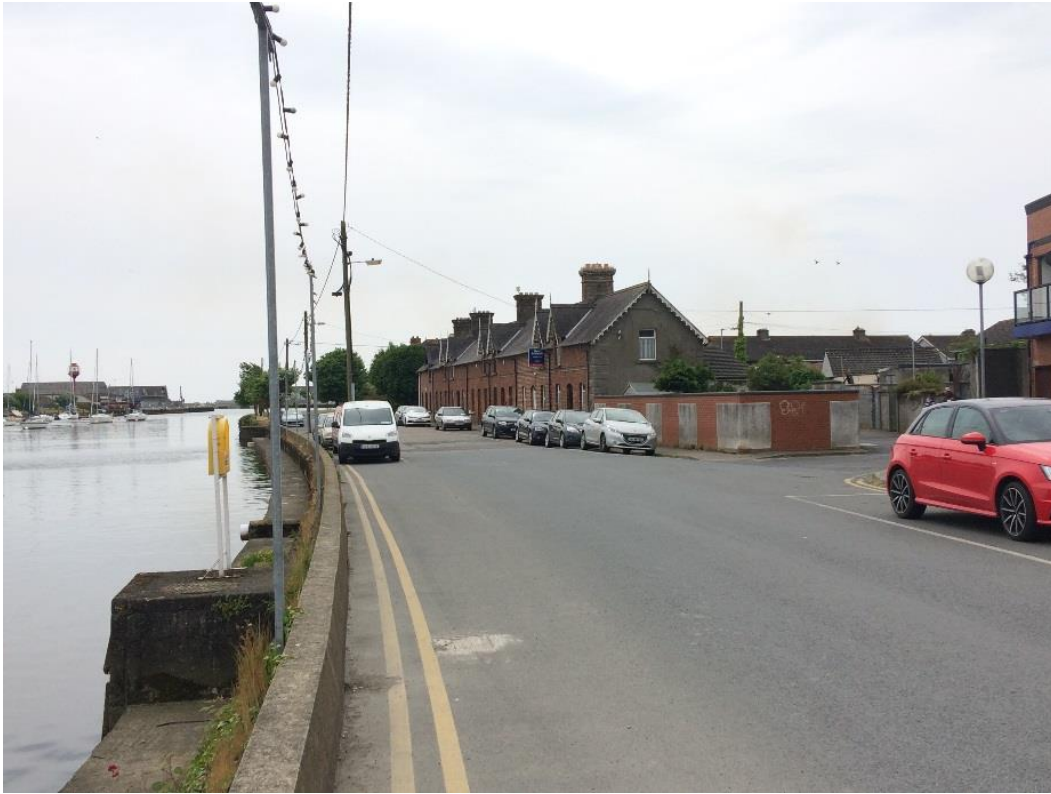
Figure 12.12: South Quay, facing southeast

The proposed interceptor sewer follows the path of South Quay as it re-joins the road from the river channel. This section of the roadway is bounded to the southwest by a mixture of modern and vernacular properties (**Figure 12.12**).

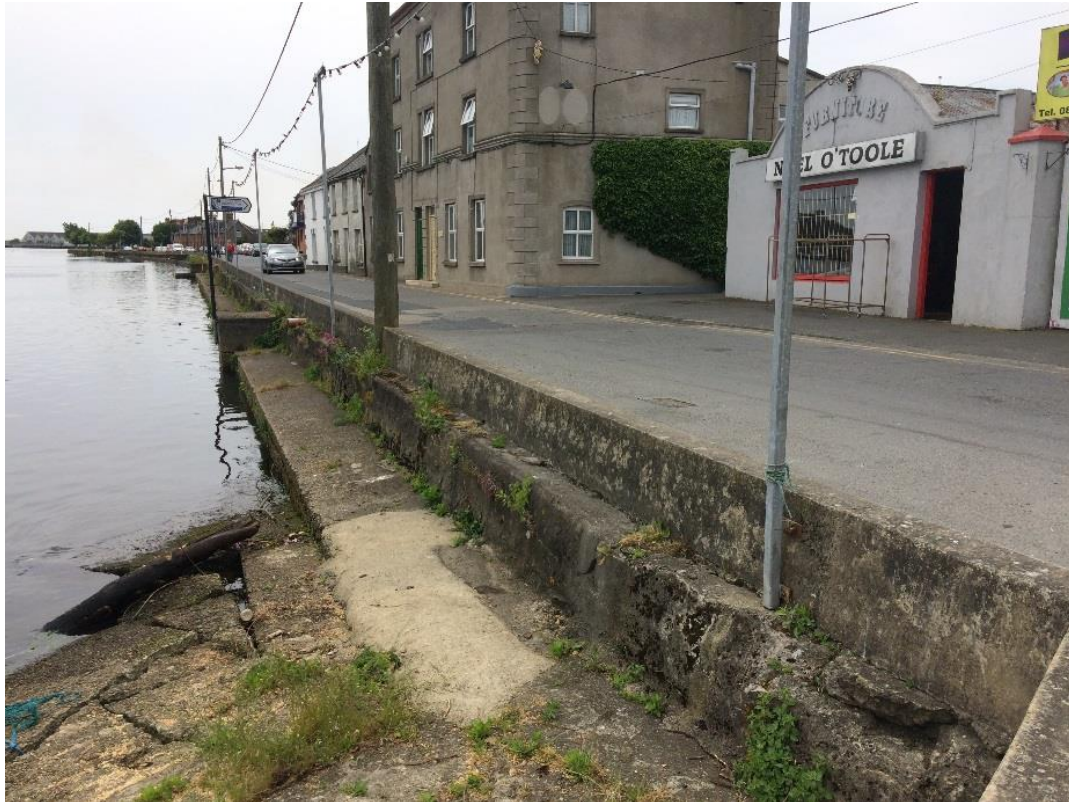
Figure 12.13: South Quay wall, facing south-southeast

The quay wall, although present in sections, has been subject to alteration and large sections have been rendered with cement (**Figure 12.13**). Just to the northwest of the harbour, the pipeline will be tunnelled across the river to the North Quay from South Quay.

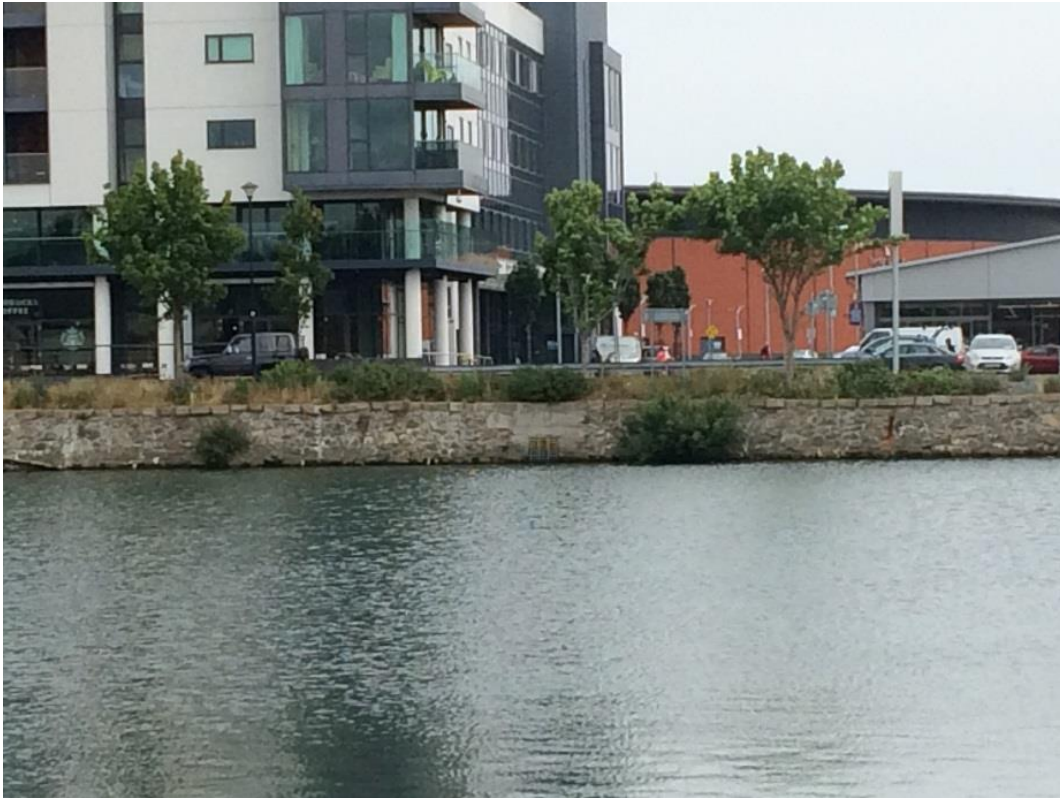
Figure 12.14: Section of the rubble North Quay wall, facing northeast

The proposed sewer will be tunnelled along the North Quay along existing modern roads. Sections of the North Quay wall is apparent bounding this stretch of the river. It is formed by roughly worked masonry blocks (**Figure 12.14**).

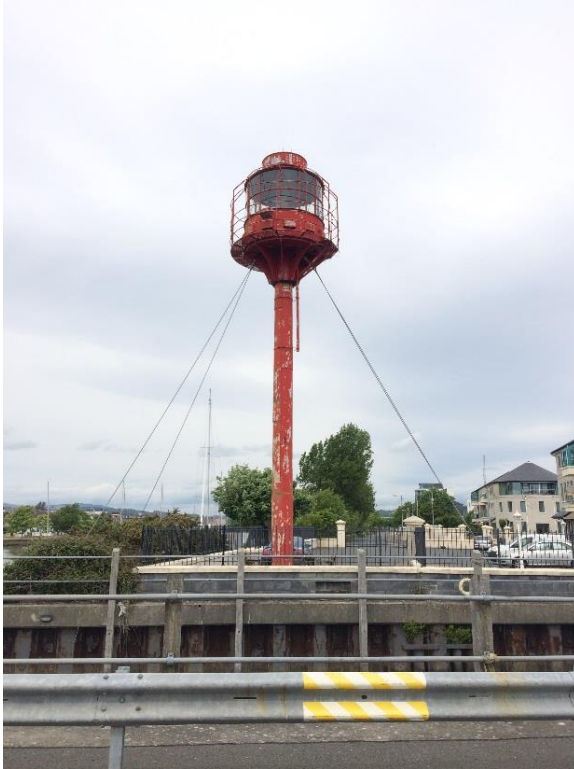
Figure 12.15: Early 20th century shipping beacon (NIAH Ref.: 16322030), facing northwest

The surrounding development is modern in nature. The only structures of heritage merit is the early 20th century shipping beacon (NIAH Ref.: 16322030) (**Figure 12.15**), located 60m to the northwest and the former Salvage Store, which is a structure that fronts onto North Quay and dates to the early 19th century. The Salvage Store building is single storey, of roughly coursed masonry construction. Larger windows have been inserted at a later date into the fabric with red brick reveals (**Figure 12.16**).

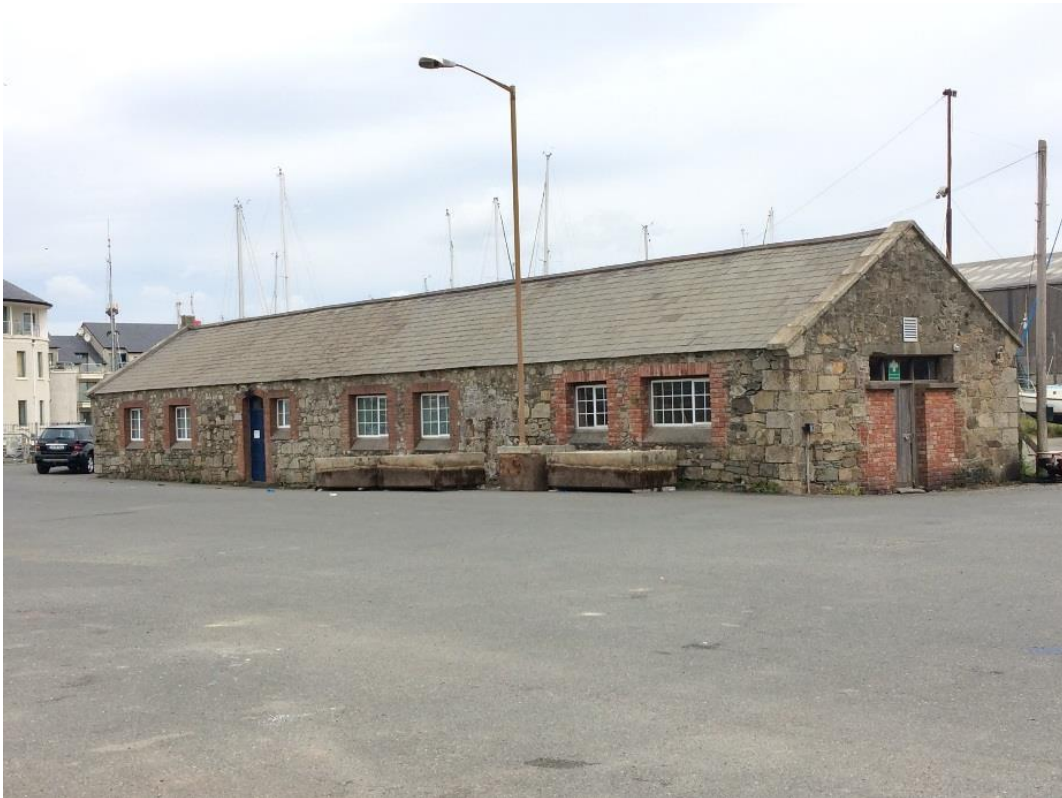
Figure 12.16: Early 19th century Salvage Store, facing north

The original vehicular entrance in the eastern gable end has been blocked up and a pedestrian entrance inserted. The Salvage Store is located outside of the planning boundary.

No previously unrecorded sites of architectural heritage merit were noted during the course of the field inspection, with the exception of the now altered, early 19th century former Salvage Store, located adjacent to the proposed scheme on the North Quay.

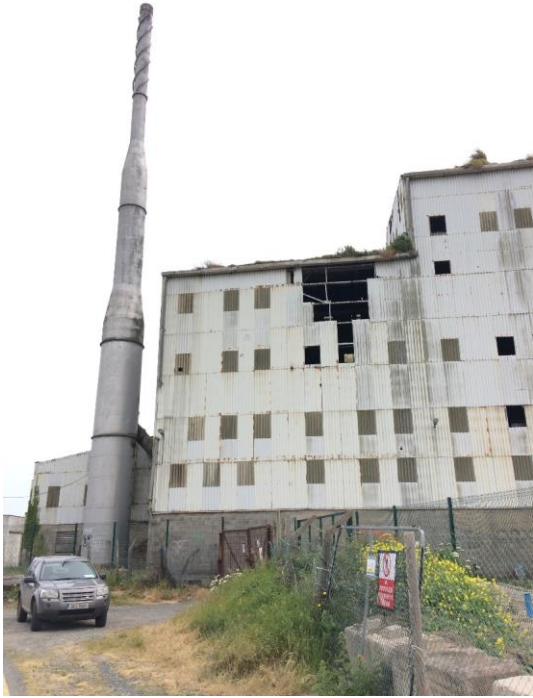
Figure 12.17: Existing factory structure within the WwTP site, facing northeast

The WwTP site is currently occupied by a late 20th century factory associated with its former use as a plaster board production site (Figure 12.17). The factory is very derelict and includes a tall metal chimney stack.

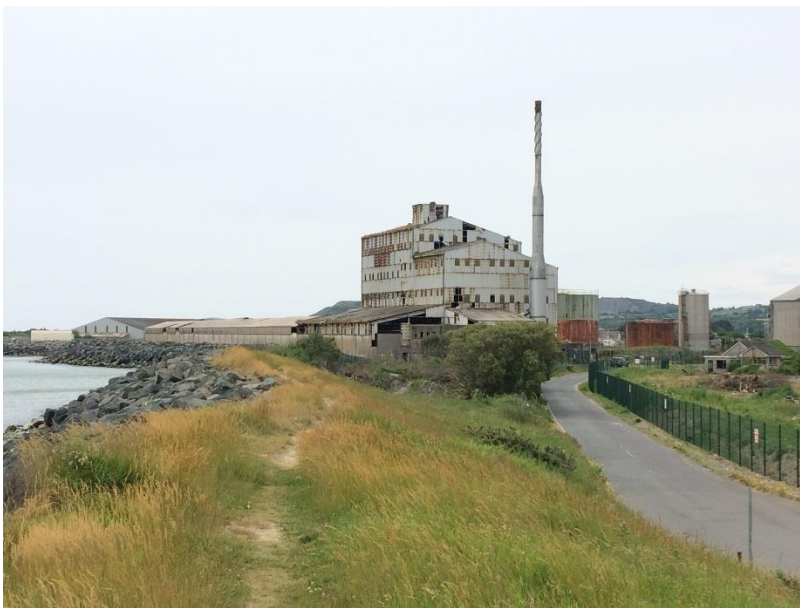
Figure 12.18: WwTP site with coastal rock armour, facing south

There are a number of ruined modern structures within the site, but nothing remains that relates for the former explosives factory. The site is bounded to the east by modern rock armour sea defences (Figure 12.18).
